### Spotlight on Safety Story

<p><b>Title of Spotlight on Safety Story: Is the “PICC” ture perfect ? Arterial malposition of long line</b></p> <p><b>Name &amp; Role: Nithya Lakshmipathy ST5 Paediatric registrar, Dr Raju Narasimhan consultant neonatologist</b></p> <p><b>Workplace: Royal Preston Hospital</b></p>	
<p><b>Situation</b></p>	<p>An extreme preterm neonate developed signs of vasospasm of the upper limb. This was following an inadvertent arterial cannulation during PICC line insertion and infusion of parenteral nutrition. The arterial malposition was identified on retrospective review of serial x- rays .</p>
<p><b>Background</b></p>	<p>26 weeker, one of triplets with a birth weight of 800 grams was ventilated for SDLD and had umbilical lines in situ. On day 5 of life a long line was inserted in the left antecubital fossa for TPN administration. No undue complications of line placement were recorded.</p> <p>An x- ray was done to confirm line position which revealed the line was well into the heart (<b>Fig .1</b> ).The line was withdrawn and the repeat x- ray after manipulation (<b>Fig .2</b>) was deemed satisfactory for use.</p> <p>On day 3 of long line use there were concer

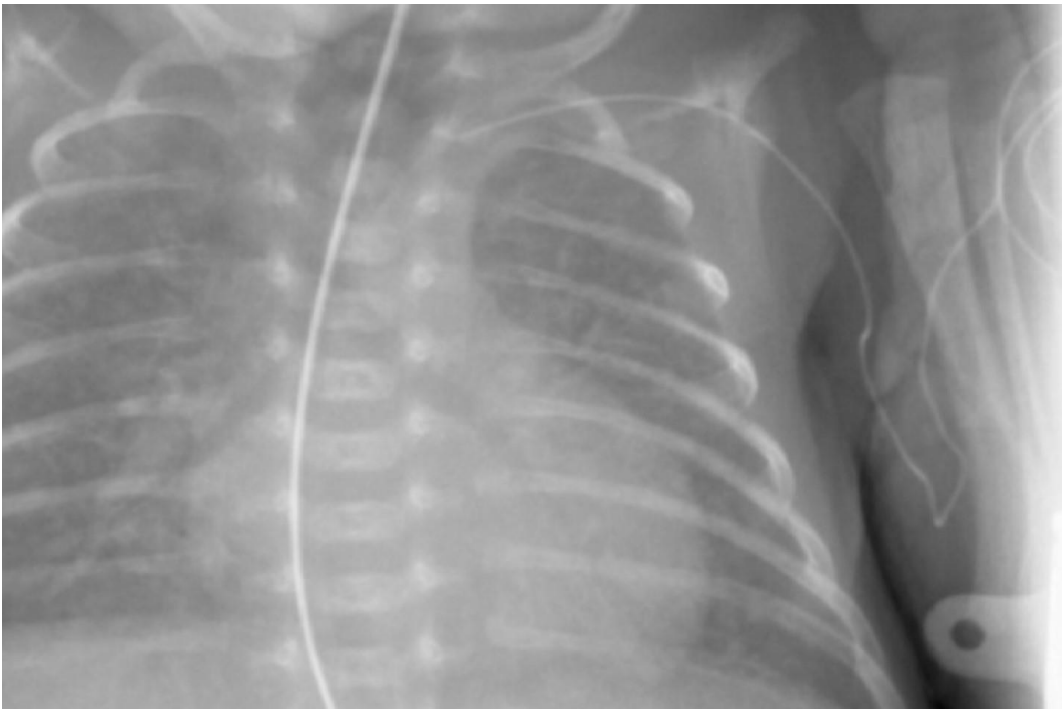
Fig 2 X ray after long line manipulation

<p><b>Assessment</b></p>	<p>The signs of acute vasospasm were recognised and the long line was removed immediately. Topical Glyceryl trinitrate patch was applied and over the next five days there was a gradual improvement of perfusion. No residual ischaemic injury was noted.</p> <p>Serial X -rays were reviewed retrospectively with the consensus that the initial line tip was in the ascending aorta (<b>Fig. 1</b>) . After adjustment, the catheter tip was in the subclavian artery but misinterpreted as being in the subclavian vein (<b>Fig. 2</b>) .</p>
<p><b>Recommendation</b></p>	<ol style="list-style-type: none"> <li>1.It is important to familiarise oneself with vascular anatomy- A left-sided long line should cross the midline to enter the superior vena cava .</li> <li>2.Always review serial X -rays to assess optimal line position. The most recent x-ray provides a snapshot but does not reveal the full picture.</li> <li>3. Ensure regular review and documentation of central line positions by senior members of staff.</li> <li>4.Other clues to arterial placement are blood gas, Colour/flow of blood on cannulation and flow of contrast from the line tip. ECHO can also aid in confirming line position.</li> <li>5. Remove a PICC line promptly if any complication is suspected.</li> <li>6.Prompt use of Glyceryl trinitrate minimises residual ischaemic changes.</li> </ol>

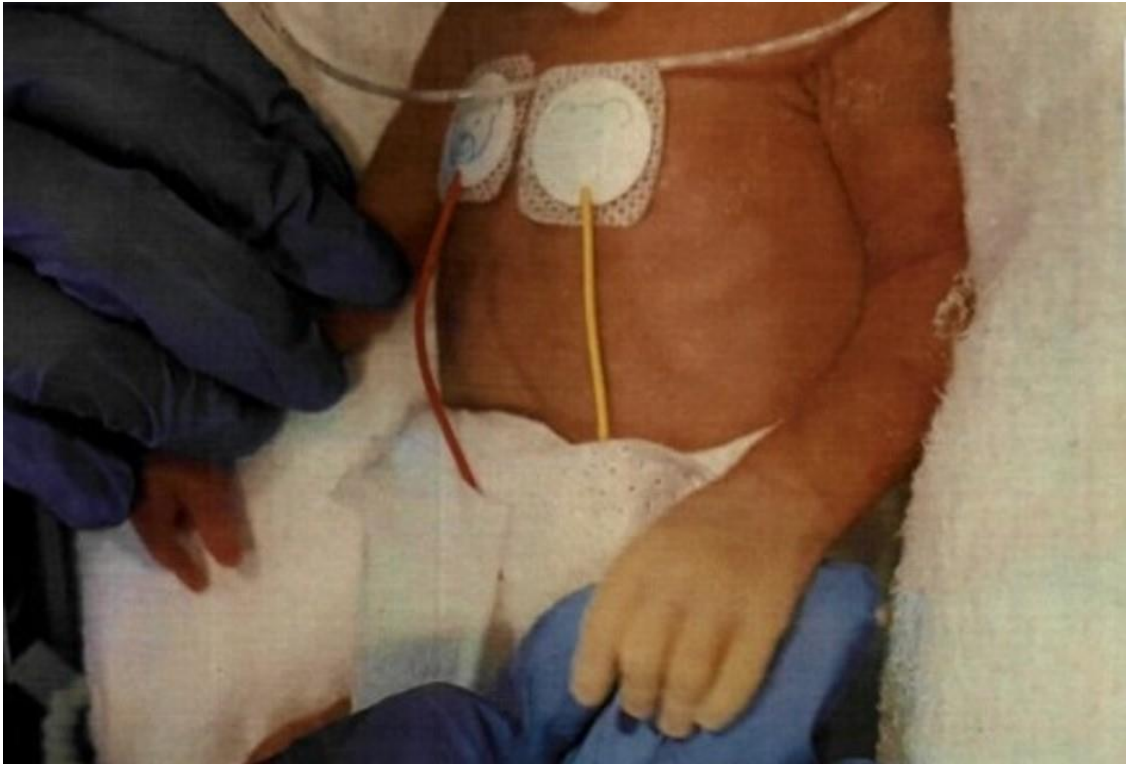
Fig 3 Vasospasm of the left arm

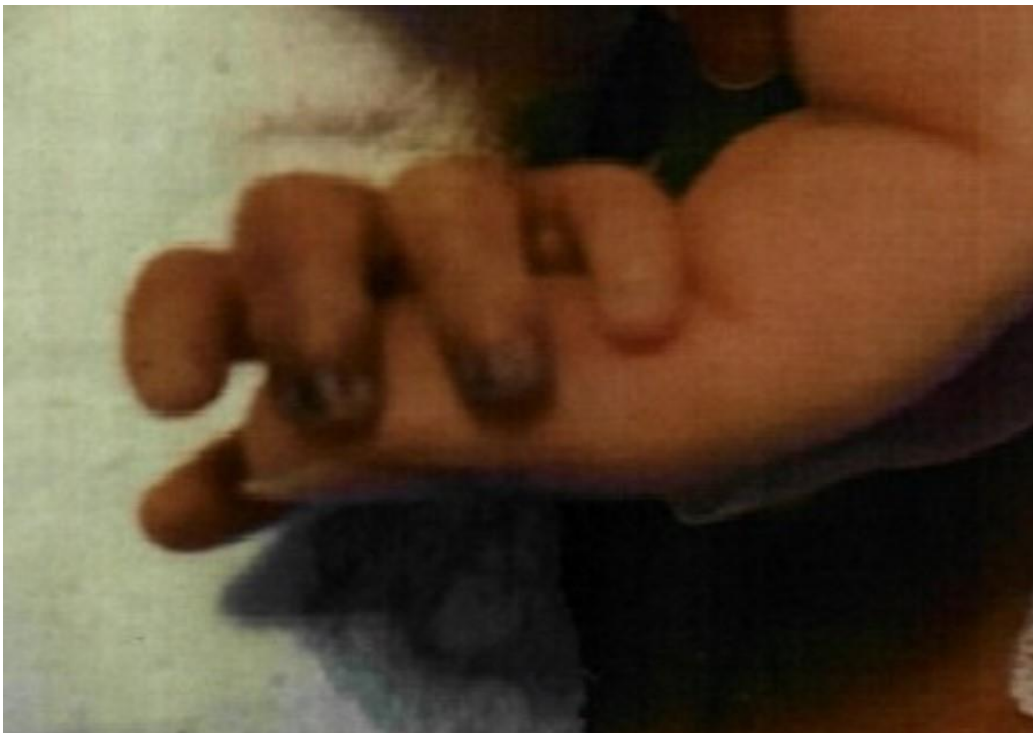
Fig 4 Dusky distal phalanges (middle and ring fingers).
